**Oak Meadows HOA
Road 13 and Oak Meadows Blvd
Firestone, CO 80504**

Level 1 Reserve Analysis

Report Period – 01/01/14 – 12/31/14

Summary of Oak Meadows Owners Assoc. -**Assoc. ID # - 04045-13**

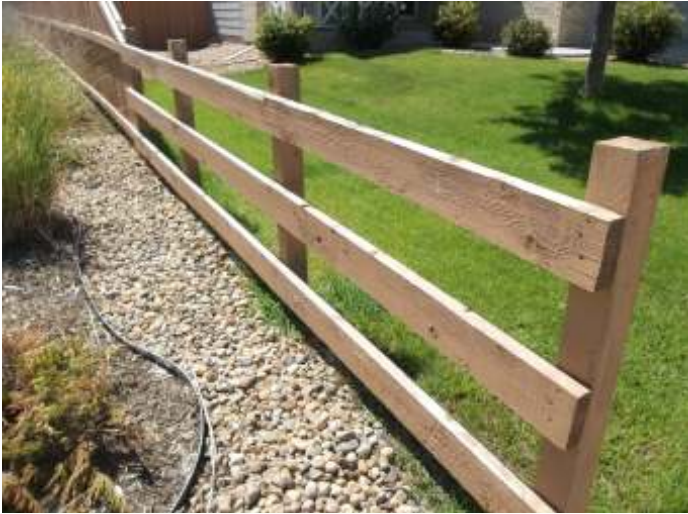
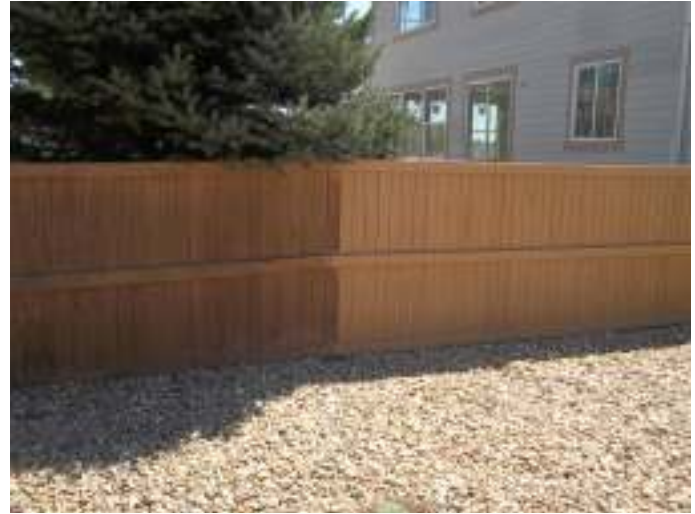
Comp #: 209 Wood Fencing - Restain

Condition of fence stain varied from location to location. Overall, the stain was showing signs of thinning and some missing/bare wood was observed in some areas. Due to the observed conditions we recommend reserving to restain this fiscal year (2014) to maximize the useful life of the fence. It is generally recommended that wood fencing in this climate is stained every 3 - 4 years to protect the materials from the elements.

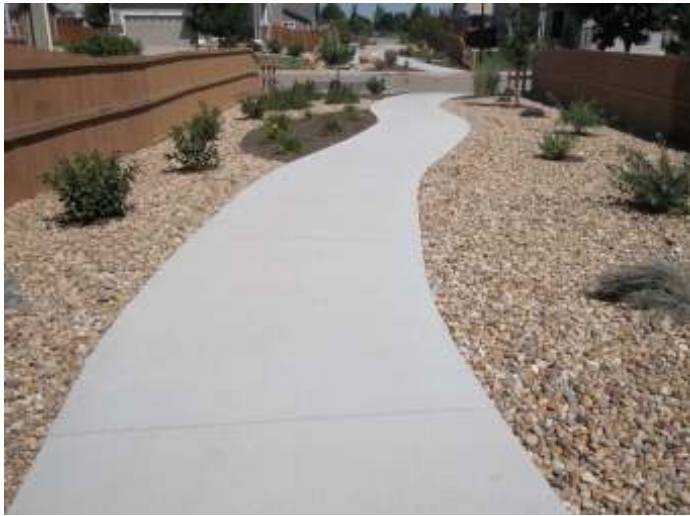
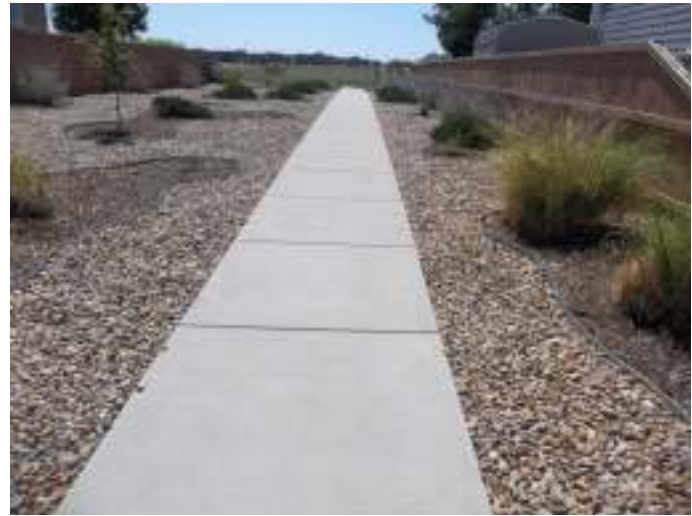
Comp #: 601 Concrete Surfaces - Repair

Installed sidewalks were in good condition with no visible damage or trip hazards. Sidewalk in Tract L has yet to be installed. Due to the overall good condition of sidewalk and since it is unlikely that all concrete surfaces will fail at the same time we suggest establishing a Reserve fund for major repairs and replacement to approximately 5% of area (710 GSF) every 4 years. We have reduced the percentage of concrete to be repaired/replaced due to the observed good conditions. The cost and/or frequency of this project can be adjusted upon updating this report if necessary.

Allowance to repair 5% of sidewalks every 4 years

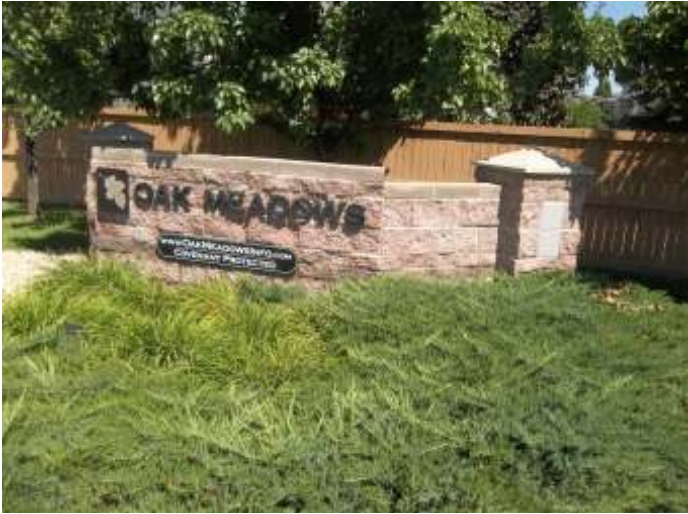
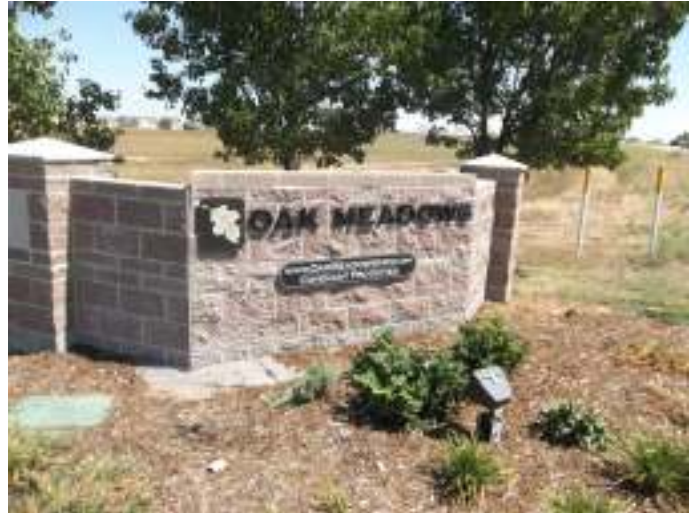
Comp #: 801 Monuments - Rebuild

Overall, monuments appeared in good condition with no observed problems with the cut-face CMU block or the logos and lettering. Monuments are built using "lifetime" materials and the cause for replacement is not likely going to be due to the failure of the materials. The usual reason for replacement is to keep the area up-to-date in terms of décor as well as to ensure an appropriate appearance to the community entrances. We have used the average age of all monuments to establish the remaining useful life as it is unlikely that (2) monuments would be updated while the other (2) monuments remain in original condition/style. Expect a useful life of approximately 15 - 20 years from these components.

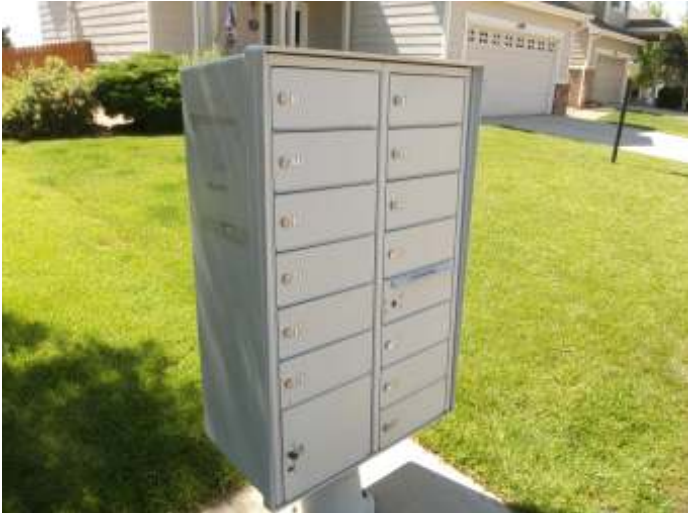
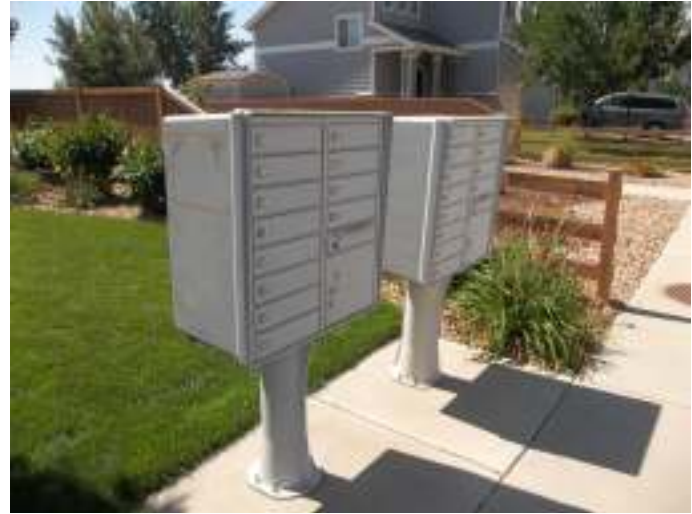
Comp #: 803 Mailboxes - Replace (2000/02)

Mailbox stations are rusting at the base where they are anchored into the concrete pad. We recommend painting the mailbox bases in order to maximize the useful life of the units. According to several manufacturers, the typical life expectancy for this type of mailbox is 15 - 20 years in this environment. Remaining life is based on average age of all units. While it is possible the US Post Office will maintain and replace these boxes in the future, in our experience, we have seen in numerous similar circumstances that the post office makes the association responsible for replacement. This line item is included as a conservative measure in case the post office decides the association is responsible for replacement.

\$1650/CBU; Estimate to replace

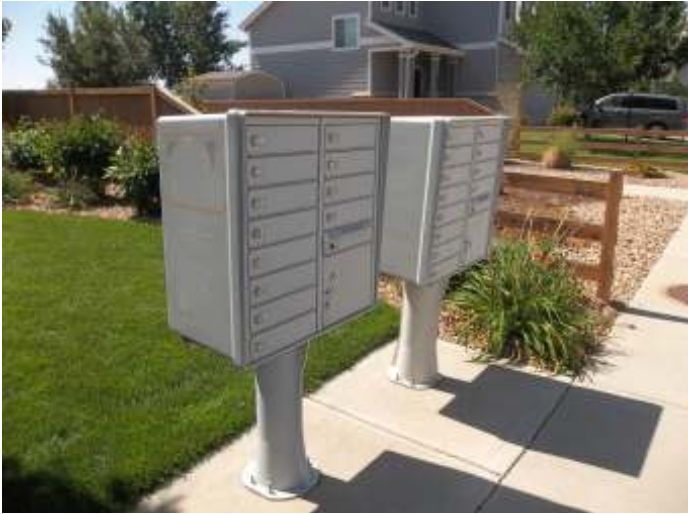
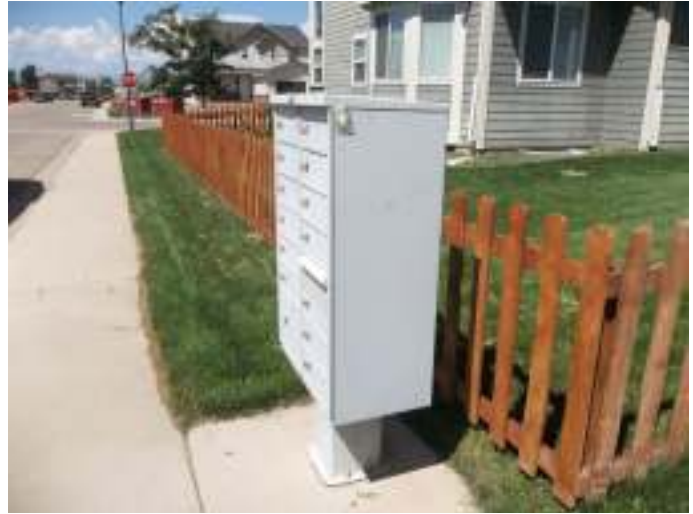
Comp #: 804 Mailboxes - Replace (2004/05)

Mailboxes appeared to be aging as expected. According to several manufacturers, the typical life expectancy for this type of mailbox is 15 - 20 years in this environment. Remaining life is based on average age of all units. While it is possible the US Post Office will maintain and replace these boxes in the future, in our experience, we have seen in numerous similar circumstances that the post office makes the association responsible for replacement. This line item is included as a conservative measure in case the post office decides the association is responsible for replacement.

Best Cost: \$4,950
\$1650/CBU; Estimate to replace

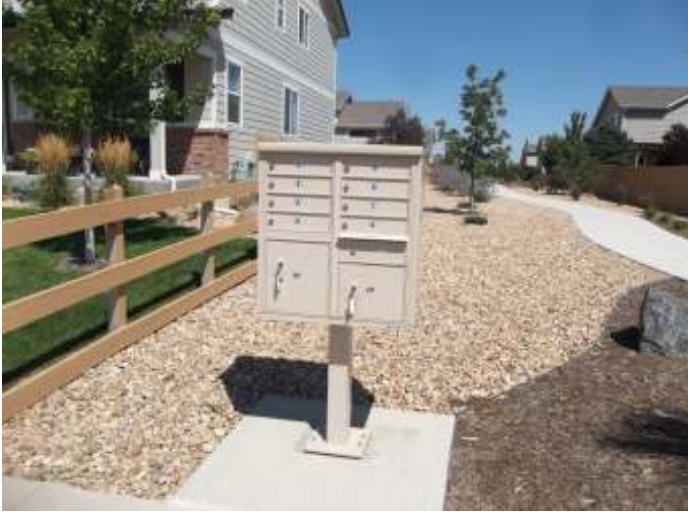
Comp #: 805 Mailboxes - Replace (2010)

Picture Unavailable

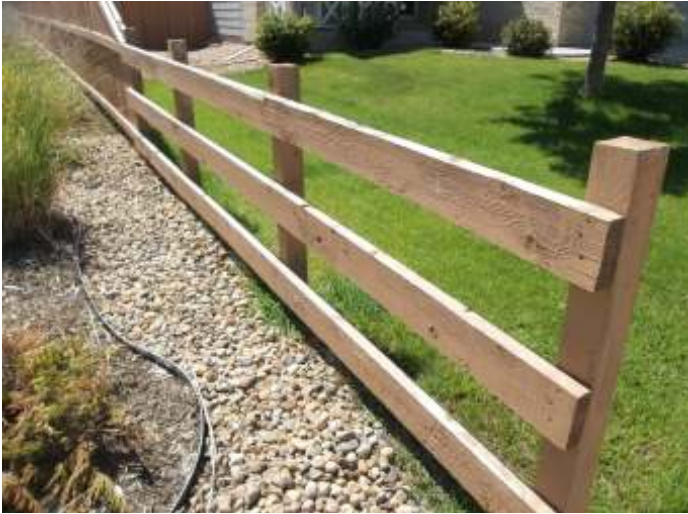
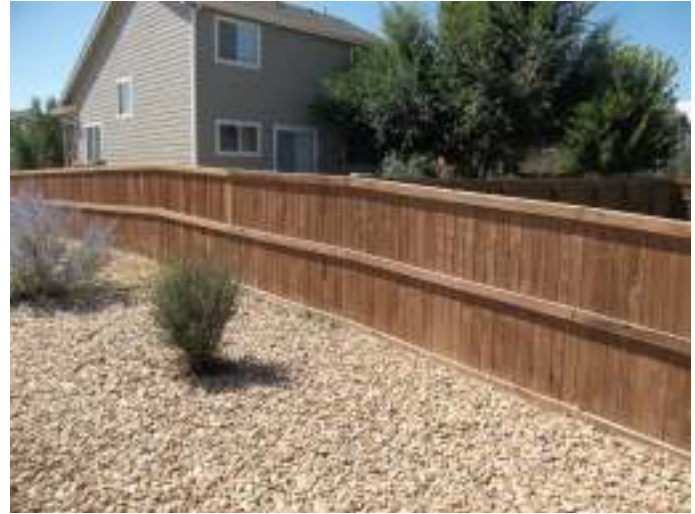
Comp #: 1001 Wood Fencing - Replace

Once fencing is installed in these tracts the association will only be responsible for the assumed linear footage noted in the general notes. Upon update of this report, we will measure the new areas and include actual quantities in the new version of this report. It was reported that all other fencing will be the responsibility of the individual home owner.

NOTE: This line item includes privacy and rail fencing as it is assumed to be constructed in the future to match other areas of the community.

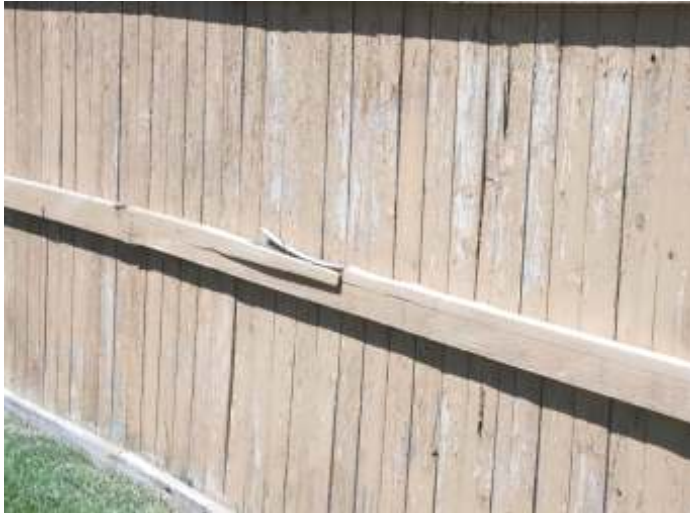
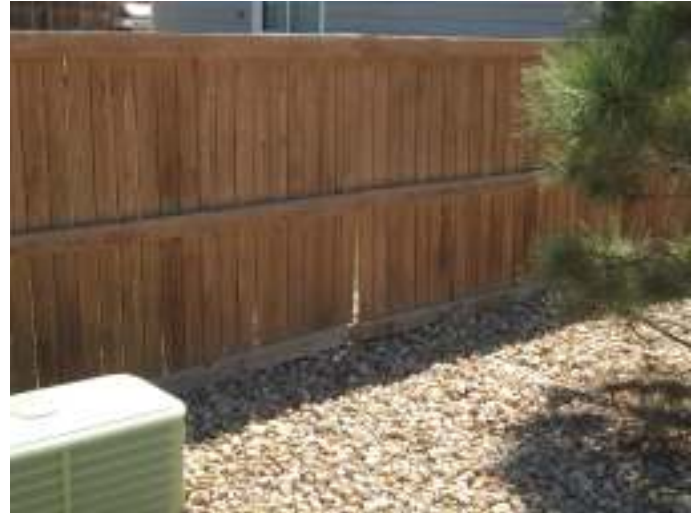
Comp #: 1001 Privacy Wood Fencing - Replace

Community fencing appeared in fair condition throughout. The most overt issues with the fencing were the cross members of the fence and the bowed and broken slats along the bottom of the fence. The rails were bowed and checking in many areas throughout the neighborhood. We have provided an allowance for replacement as opposed to complete replacement since the age of the fences vary. This method of funding should allow the association to make needed repairs to newer fencing as well as completely replacing approximately 50% of the older fencing. Expect a useful life of approximately 12 years if properly maintained and frequently and regularly stained (see comp #209).

Allowance to replace approx. 50% of fence

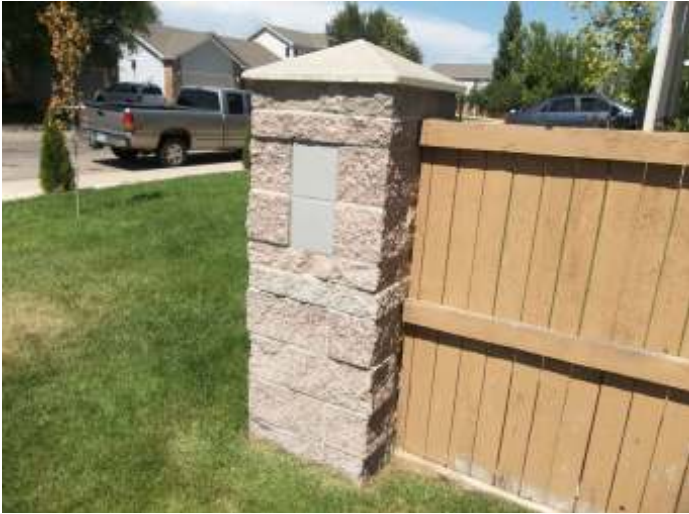
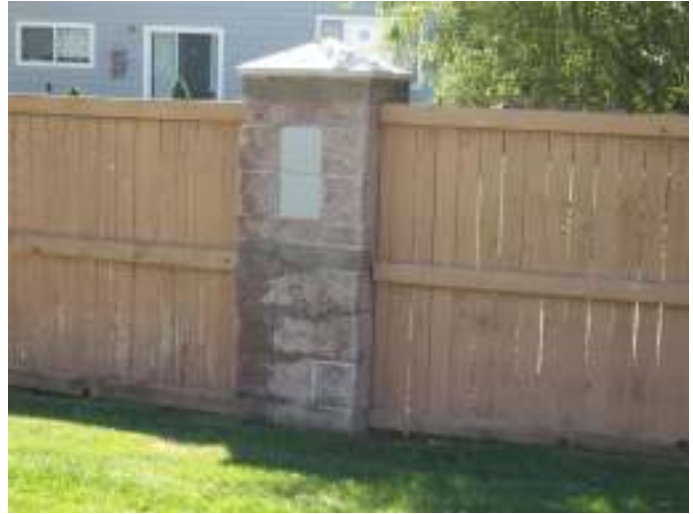
Comp #: 1005 Block Columns - Replace

Cut-face CMU fence columns appeared in good condition with no overt signs of unusual conditions. With proper maintenance and care, these structures should have an extended useful life. At this time, there are no plans for future replacement. Reserve funding is not recommended for this component at this time.

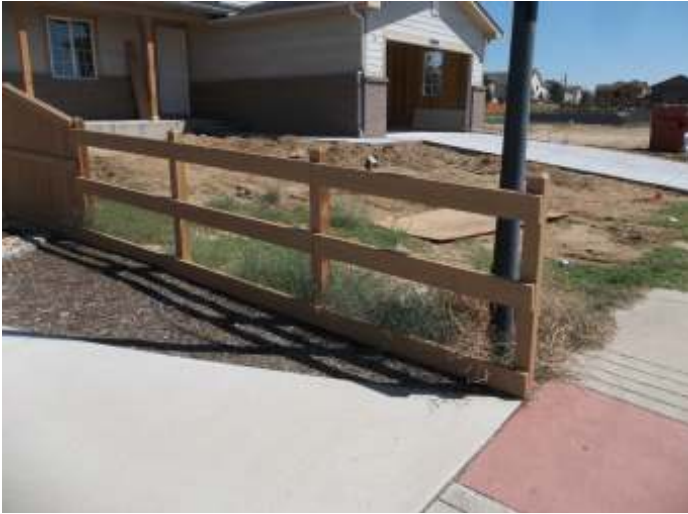
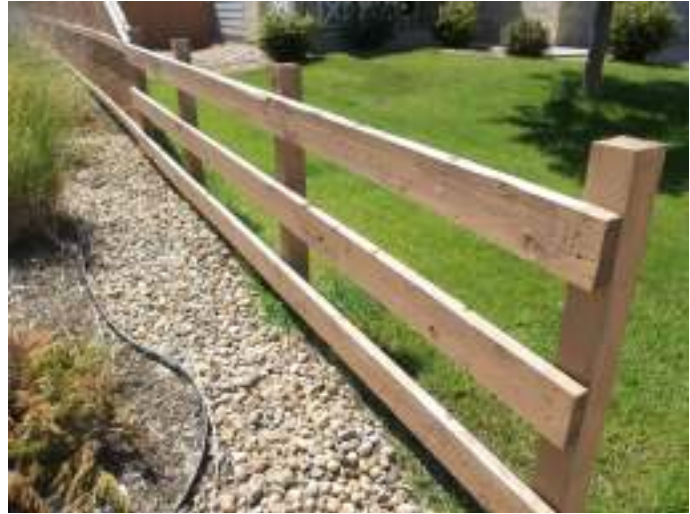
Comp #: 1009 Rail Fencing - Replace

Majority of rail fencing appeared in fair condition with some signs of repairs and only a very thin coat of stain apparent from the last restaining project. These fences appear to be construction grade materials and therefore the useful life of the fence will be shorter than what is typical. We have provided an allowance to replace approximately 50% of the rail fencing as the age of the fences varies. Expect to perform repairs to newer fence and replace approximately 1/2 of the rail fencing on the property every 5 - 10 years if properly maintained and frequently and regularly stained (see comp #209)

Allowance to replace approx. 50% fence

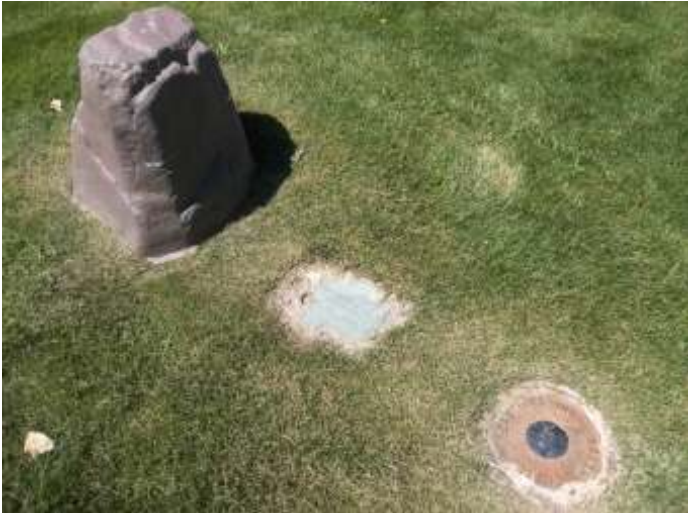
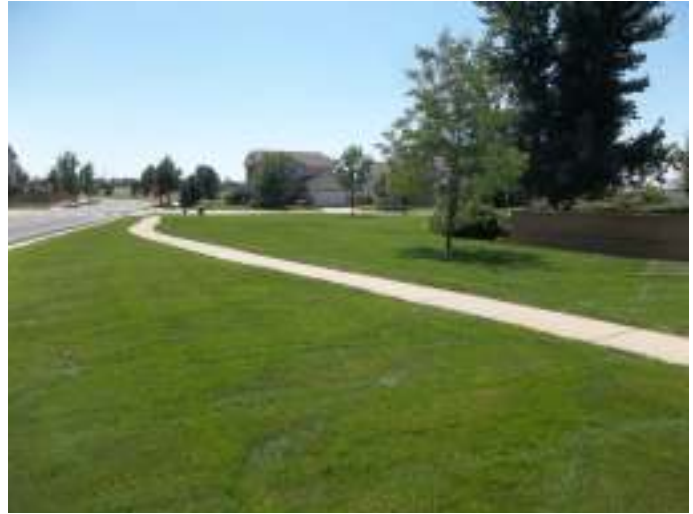
Comp #: 1701 Irrigation System - Rebuild

We suggest the association continue to fund this component to maintain or improve the system as technology continues to improve in water management. Through better water management, the association may quickly realize a significant cost savings.

Allowance for major repairs

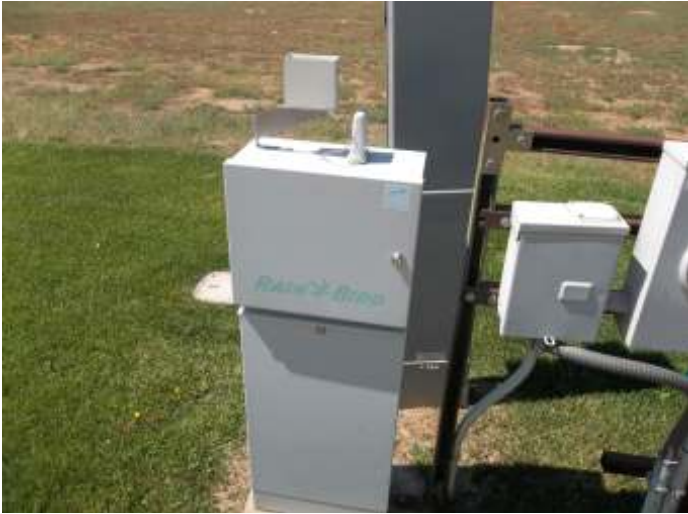
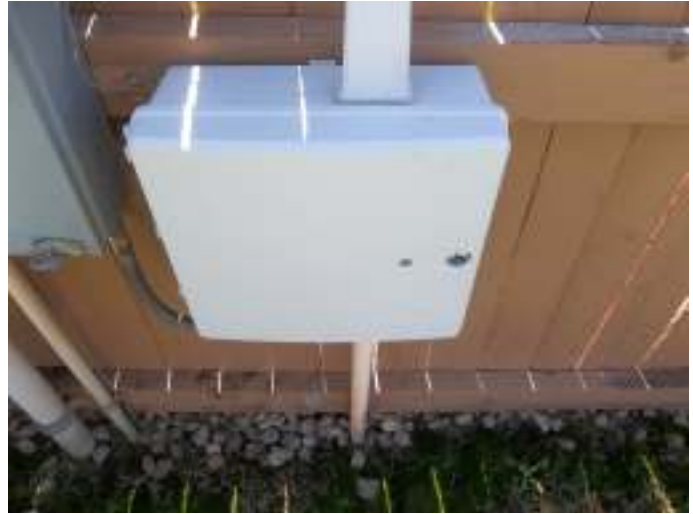
Comp #: 1703 Irrigation Timeclocks - Replace

Under normal conditions (not including Acts of God, vandalism, etc.) these clocks should last 10 - 12 years with proper maintenance. Due to advances in technology and water efficiency, we suggest reserving to replace all clocks at the same time. A lot of communities are upgrading to ET type controllers and the costs reflect this. Remaining useful life based on average age of all clocks.

Best Cost: \$8,800
\$2,200/clock; Estimate to replace

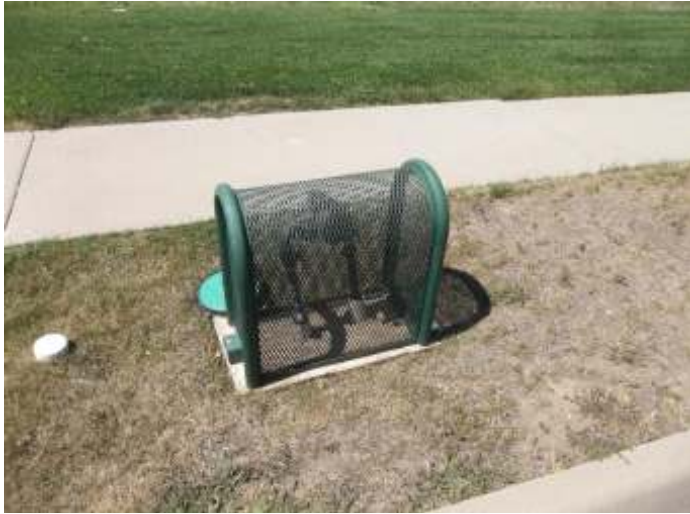
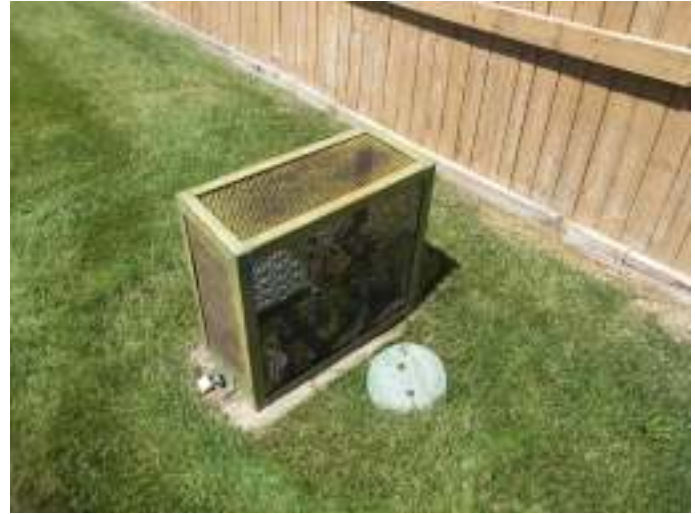
Comp #: 1706 Backflow Devices - Replace

There were no unusual conditions observed or reported with devices at time of observation. It is difficult to predict a life expectancy for backflow preventers. Often, the device can be rebuilt as opposed to being completely replaced. Treat any repairs as needed as a general maintenance expense. No separate Reserve funding is required for this asset.

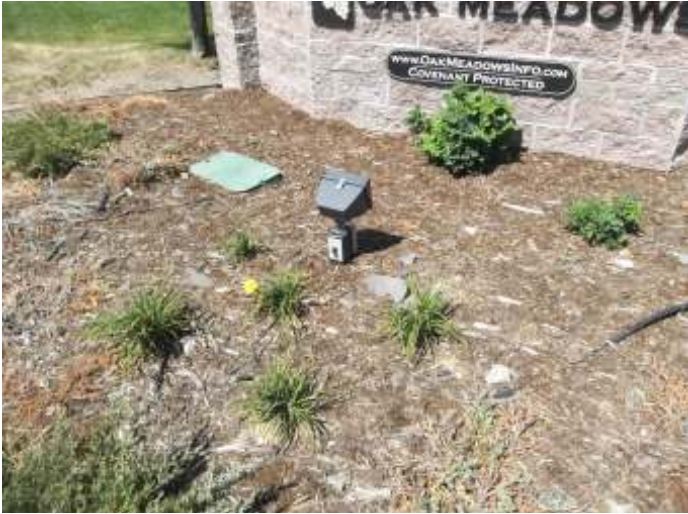
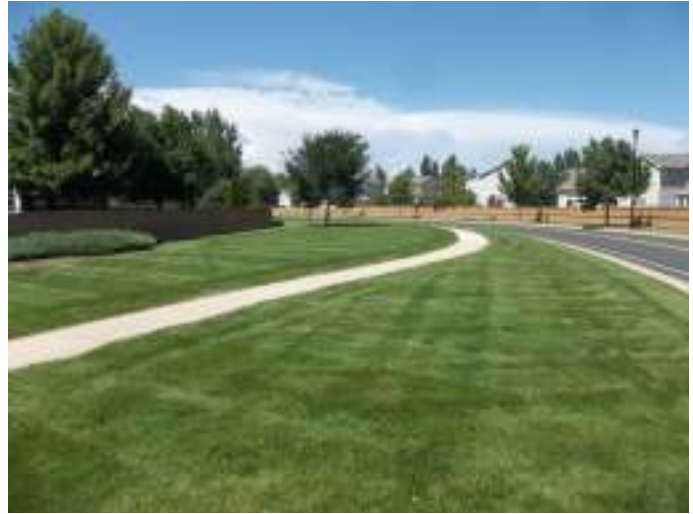
Comp #: 1801 Landscaping - Refurbish

This allowance is for landscaping repairs, replanting, and or redesign. This is meant to cover the costs associated with landscaping projects that lie outside the scope of routine maintenance. It was reported that the association typically spends \$2,000 - \$3,000 annually on "extra" landscaping expenses. This reserve allowance is meant to take the place of annual operating expenses so the association can plan for these projects. Once the new areas of landscaping are completed, it will be necessary to increase the amount of funding on this line item to cover the cost of the future projects in tracts A, B, T and D.

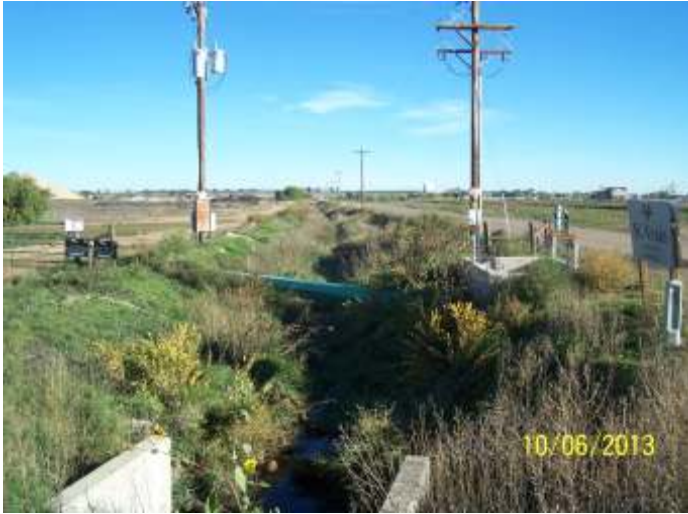
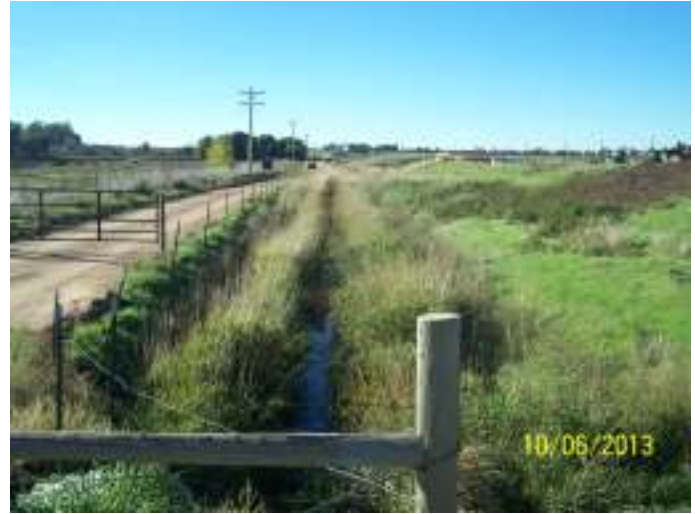
Comp #: 1803 Ditch - Dredging

The ditch appeared in good condition at time of observation with no outstanding issues at time of observation. It was reported that the association was forced to fund for the dredging of the ditch within the past couple of years. This ditch is actually installed to the North of the property and outside the perimeter of Oak Meadows. However, due to zoning and local jurisdiction, the responsibility is Oak Meadow's. Reserve to dredge ditch every 10 years.

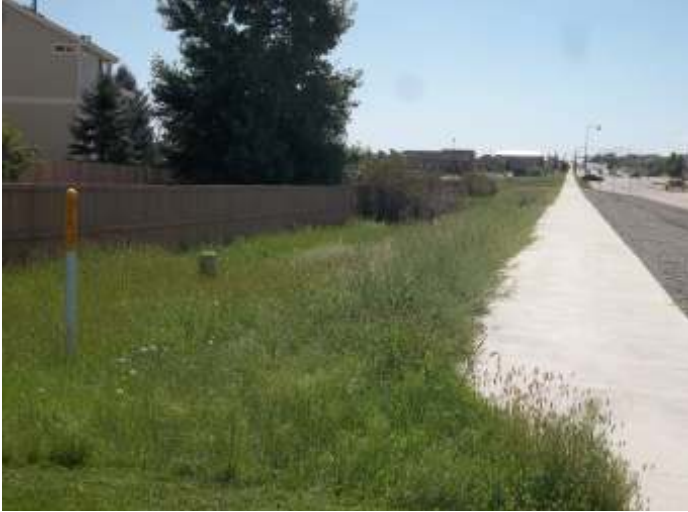
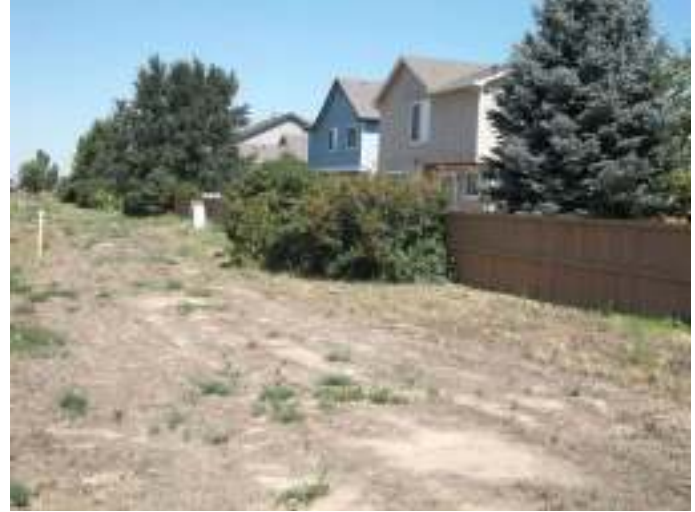
Comp #: 1806 Tract A Landscaping - Refurbish

Tract A was observed to be derelict in terms of landscaping. The area was mostly native grasses and weeds at time of observation. This line item was added at the behest of the BOD. The original construction of the space is going to be completed in 2014. The "99" year useful life is to show this line item as a "one-time" occurrence. Once the new landscaping is installed, it will be necessary to reserve an allowance for future refurbishment, however, until such a time as this project is completed, this is the only funded line item for this landscaping.

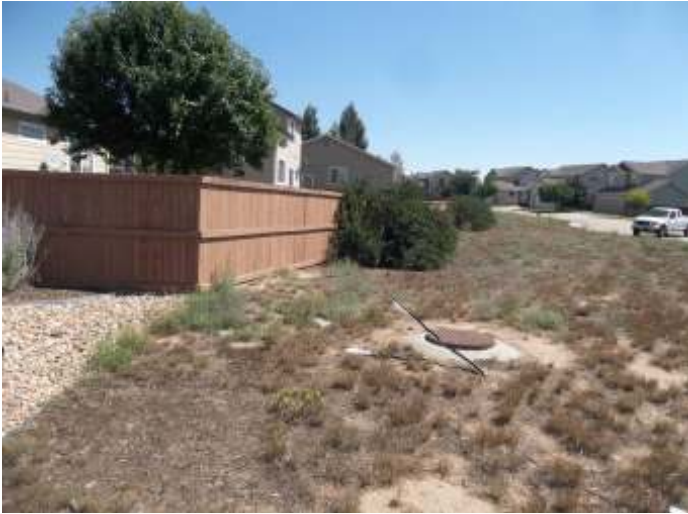
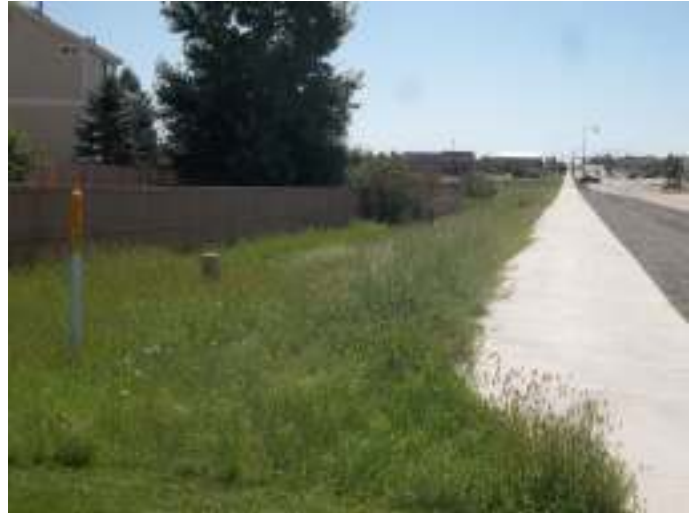
Comp #: 1807 Tract T/D Landscaping - Refurbish

Tract T and D were observed to be derelict in terms of landscaping. The areas were mostly native grasses and weeds at time of observation. This line item was added at the behest of the BOD. The original construction of the space is going to be completed in 2016. The "99" year useful life is to show this line item as a "one-time" occurrence. Once the new landscaping is installed, it will be necessary to reserve an allowance for future refurbishment, however, until such a time as this project is completed, this is the only funded line item for this landscaping.

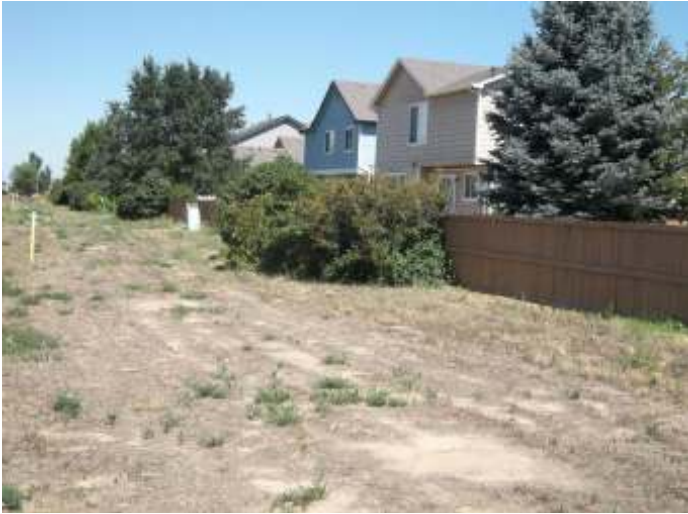
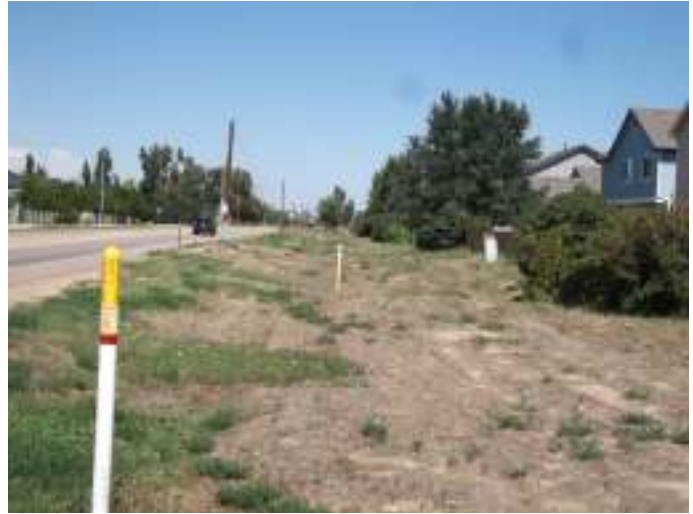
Comp #: 1808 Tract B Landscaping - Refurbish

Tract B was observed to be derelict in terms of landscaping. The area was mostly native grasses and weeds at time of observation. This line item was added at the behest of the BOD. The original construction of the space is going to be completed in 2018. The "99" year useful life is to show this line item as a "one-time" occurrence. Once the new landscaping is installed, it will be necessary to reserve an allowance for future refurbishment, however, until such a time as this project is completed, this is the only funded line item for this landscaping.

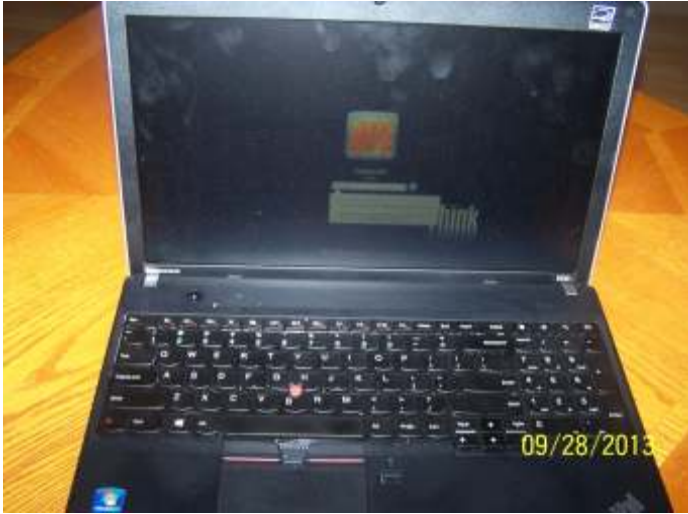
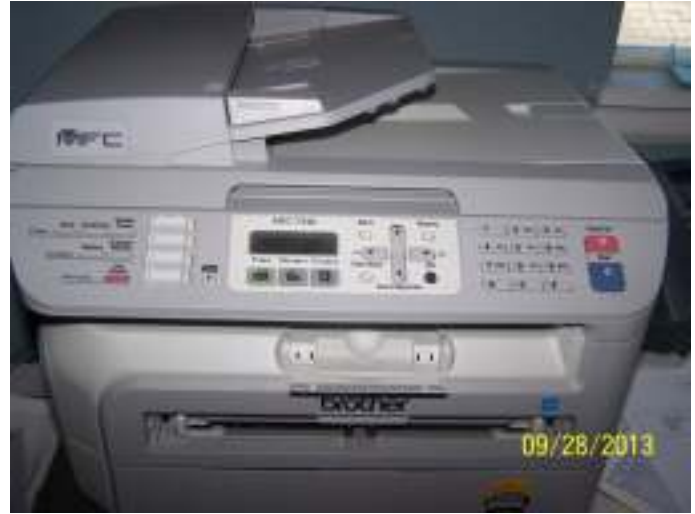
Comp #: 2001 BOD Computers/Printers - Replace

At time of observation we were unable to observe the computers or printers as they do not reside in common areas. The association had purchased laptops and printers for the BOD in order to aid them in doing their jobs. Since these are now an asset to the community, it is necessary to reserve for future replacement. Therefore, we recommend reserving to replace computers and printers every 2 - 3 years to keep up with new technology and to ensure proper function of the machines.
